**Flood Control Project Maintenance
Levee Inspections**

Maintenance Issue Types Only, Levee Inspection Report By Mile - Fall 2018

Knights Landing Ridge Drainage District

Waterway	Bank	Unit Miles	Inspection Start/End	Inspector
Unit No. 01 Knights Landing Ridge Cut	Right	6.36	10/12/2018 10/12/2018	Zach Jojola

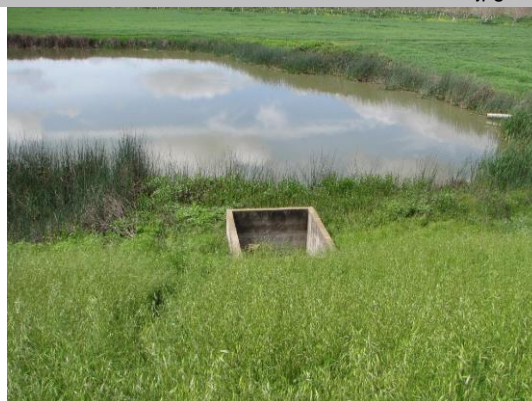
Photo 1 of 3 : UCIP_FA_2018_48010_21582.jpg

Comment Code					
Inspector Comment					
FS_ID:48010 DS_ID:19360 EP_NO: 9302 Repair Type: No Action Needed Crossing Status: Found UCIP Comments: Pipe has been grouted in place under permit 18987, 2015Pipe completely rusted through on LS slope of levee at toe/headwall of concrete distribution box. Pipe needs replacement or proper abandonment. Pipe not visible at outlet. FIELD_STRUCT_DESC: *ABANDONED* 36-inch corrugated metal drainage pipe through the levee, 27 feet below the crown. Slide gate on the waterside (WS) end. 12-foot by 6-foot concrete box on the landside (LS) end. (36-inch pipe [HLM 1.62] authorized under Automatic Board Order (ABO) issued as Permit No. 9302, 1974 - Barbara Lowe Elliott; 36-inch pipe abandoned by removing ends and pumping pipe full of concrete under Permit No. 18987, 2016 - Knaggs Ranch, LLC, care of John Brennan). [Additional Reference(s): DWR Levee Log, 1990. USACE Sacramento O&M Manual 127, June 1953, (Station 0+30)]. FS Date: 5/16/2016 3:59:29 PM

Concrete distribution box on LS toe.

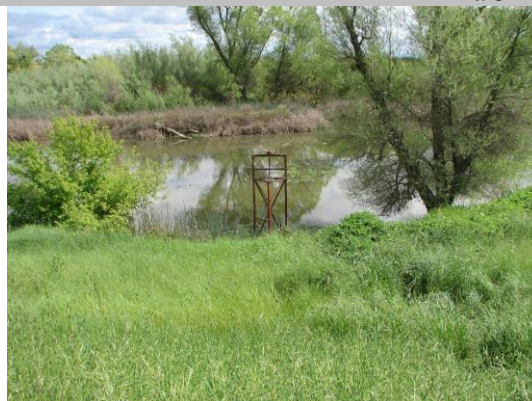
Photo 2 of 3 : UCIP_FA_2018_48010_21581.jpg

Slide gate on metal stand on WS toe. Pipe opening not visible.

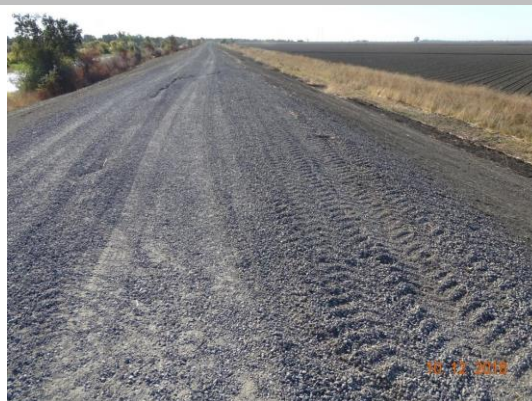
Photo 1 of 1 : FA_2018_NA0008_256_23_20181012_00044.jpg

LM Start	2.23	Rating **	M	Issue No.	23
LM End	2.23	Issue Type +	Ma	Location *	CR
Category	Earthen Levee			GPS Latitude/Longitude	
				Start	End
Item	Cracking			38.742899 °	38.742899 °
				-121.690897 °	-121.690897 °
DWR ID	DWR_NA0008_01_f_2018_23				
Comment Code					
CR1 : Monitor and have inspected by geotechnical engineer.					
Inspector Comment					
50' crack on the crown at previous sloughing site. There appears to be no bulge or sloughing on the landside slope. Slight settlement on the crown. Recommend monitoring.

View of crack and settlement on the crown. Fall 2018.

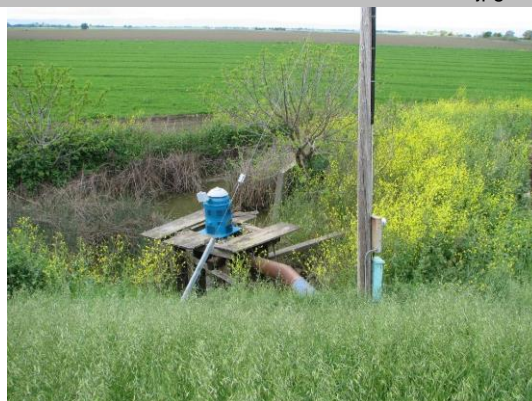
Photo 1 of 1 : UCIP_FA_2018_11067_18431.jpg

Comment Code						
Inspector Comment						
FS_ID:11067 DS_ID:19364 EP_NO: 9307 Repair Type: Non-Urgent Crossing Status: Found UCIP Comments: Siphon breaker on LS burried or broken off and missing. FIELD_STRUCT_DESC: 1 of 2: 14-inch steel drainage pipe through the levee, 5.4 feet below the crown. Pump house on a pile structure at the landside (LS) toe. Siphon breaker on the LS slope. Service pole and anchor at the LS toe. (14-inch pipe [HLM 2.62] authorized under Automatic Board Order (ABO) issued as Permit No. 9307, 1974 - Azalene E. Lowe; a 12-foot section of an existing 14-inch pipe on LS replaced and name change under Permit No. 9307-1, 2016 - Ann Grube). [Additional Reference(s): DWR Levee Log, 1990. USACE Sacramento O&M Manual 127, June 1953, (Station 123+25)]. FS Date: 4/5/2013

Pump and pipe on LS toe.

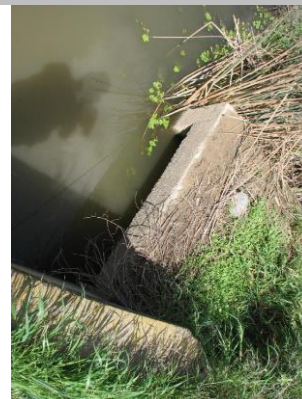
Photo 2 of 3 : UCIP_FA_2018_13205_21601.jpg

Concrete inlet on LS toe.

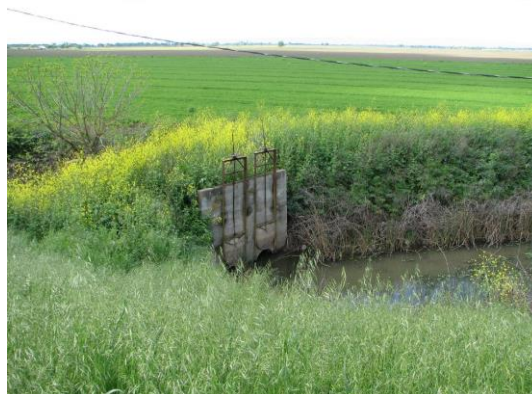
Photo 3 of 3 : UCIP_FA_2018_13205_21605.jpg

Inlet located next to concrete headwall on LS toe.

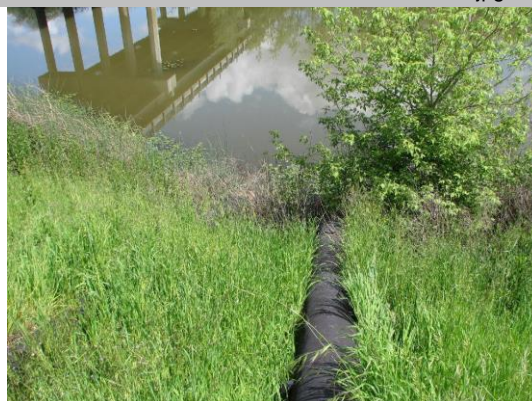
Photo 1 of 3 : UCIP_FA_2018_16105_27207.jpg

Comment Code					
Inspector Comment					
FS_ID:16105					
DS_ID:19365					
EP_NO: 9301					
Repair Type: No Action Needed					
Crossing Status: Found					
UCIP Comments:					
FIELD_STRUCT_DESC: 1 of 2: 18-inch steel drainage pipe through the levee, 6.4 feet below the crown. Siphon breaker on the waterside (WS) slope. Pump house mounted on concrete box in irrigation ditch at the landside (LS) toe. (one 18-inch and one 24-inch pipes [HLM 2.7] authorized under Automatic Board Order (ABO) issued as Permit No. 9301, 1974 - Reclamation District No. 730). [Additional Reference(s): DWR Levee Log, 1990. USACE Sacramento O&M Manual 127, June 1953, (Station 128+00)].					
FS Date: 4/5/2013

Pipe on WS slope.

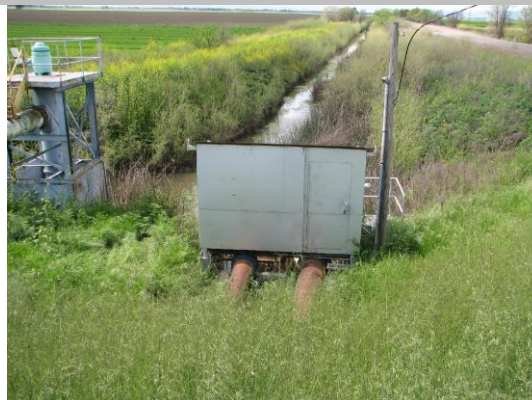
Photo 2 of 3 : UCIP_FA_2018_16105_27209.jpg

Pumphouse and pipe on LS toe.

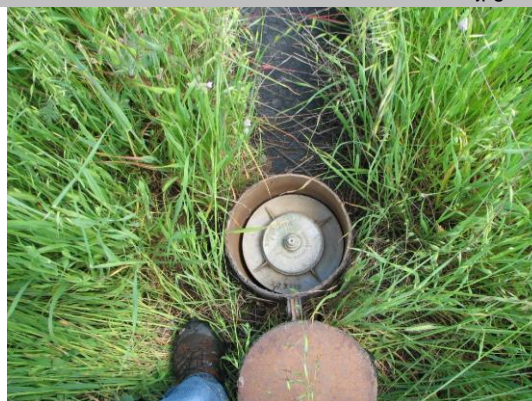
Photo 2 of 3 : UCIP_FA_2018_16106_27212.jpg

Comment Code					
Inspector Comment					
FS_ID:16106 DS_ID:19392 EP_NO: 9301 Repair Type: No Action Needed Crossing Status: Found UCIP Comments: FIELD_STRUCT_DESC: 2 of 2: 24-inch steel drainage pipe through the levee, 7.3 feet below the crown. Pump house mounted on concrete box in irrigation ditch at the landside (LS) toe. Siphon breaker in riser on the waterside (WS) slope. (one 24-inch and one 18-inch pipes [HLM 2.7] authorized under Automatic Board Order (ABO) issued as Permit No. 9301, 1974 - Reclamation District No. 730). [Additional Reference(s): DWR Levee Log, 1990. USACE Sacramento O&M Manual 127, June 1953, (Station 128+00)]. FS Date: 4/5/2013

Siphon breaker on WS slope

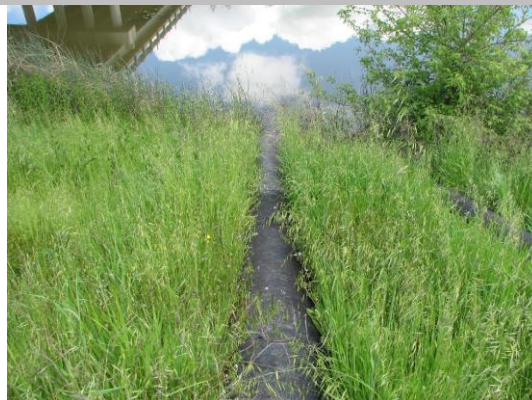
Photo 3 of 3 : UCIP_FA_2018_16106_27214.jpg

Pipe on WS slope.

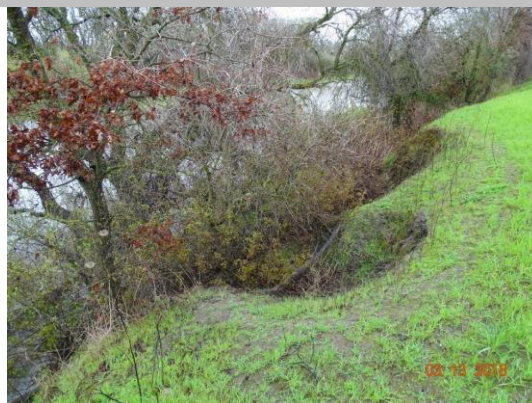
Photo 1 of 2 : FA_2018_NA0008_256_20_20180904_00005.jpg

LM Start	3.50	Rating **	M	Issue No.	20
LM End	3.50	Issue Type +	Ma	Location *	WS
Category	Earthen Levee			GPS Latitude/Longitude	
				Start	End
Item	Erosion / Bank Caving			38.759910 °	38.759910 °
				-121.696920 °	-121.696920 °
DWR ID	DWR_NA0008_01_f_2015_20				
Comment Code					
E2 : Schedule repair of erosion site prior to the next inspection.					
Inspector Comment

Updated view of erosion on the waterside slope. Spring 2018.

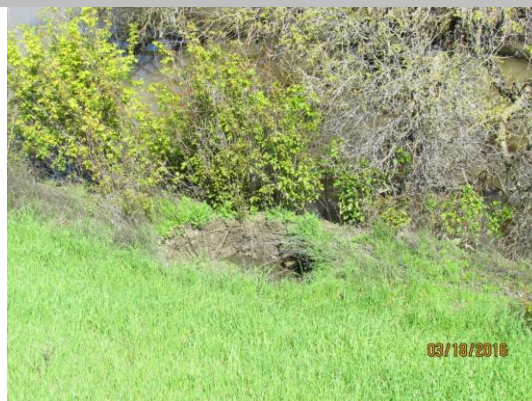
Photo 1 of 1 : FA_2018_NA0008_256_30_20180904_00010.jpg

LM Start	3.78	Rating **	M	Issue No.	30
LM End	3.78	Issue Type +	Ma	Location *	WS
Category	Earthen Levee			GPS Latitude/Longitude	
				Start	End
Item	Erosion / Bank Caving			38.762886 °	38.762886 °
				-121.700406 °	-121.700406 °
DWR ID	DWR_NA0008_01_s_2017_30				
Comment Code					
E2 : Schedule repair of erosion site prior to the next inspection.					
Inspector Comment					
Hole is at the toe of the levee on the waterward side.

View of the erosion at the toe of the levee on the waterward side. Spring 2016.

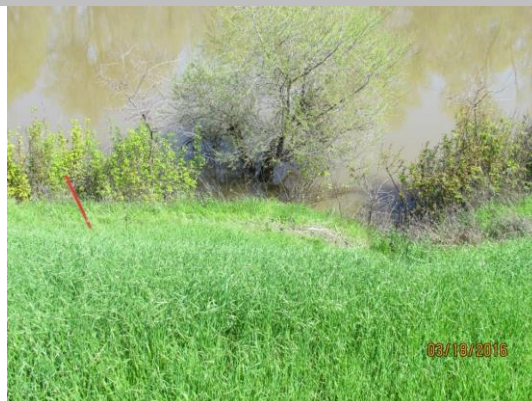
Photo 1 of 1 : FA_2018_NA0008_256_31_20180904_00011.jpg

LM Start	3.86	Rating **	M	Issue No.	31
LM End	3.86	Issue Type +	Ma	Location *	WS
Category	Earthen Levee			GPS Latitude/Longitude	
				Start	End
Item	Erosion / Bank Caving			38.763751 °	38.763751 °
				-121.701398 °	-121.701398 °
DWR ID	DWR_NA0008_01_s_2018_31				
Comment Code					
E1 : Note and monitor erosion site.					
Inspector Comment					
Erosion at the toe of the levee. LMA is monitoring erosion with stakes.

View of the erosion at the toe of the levee on the waterward side. Spring 2016.

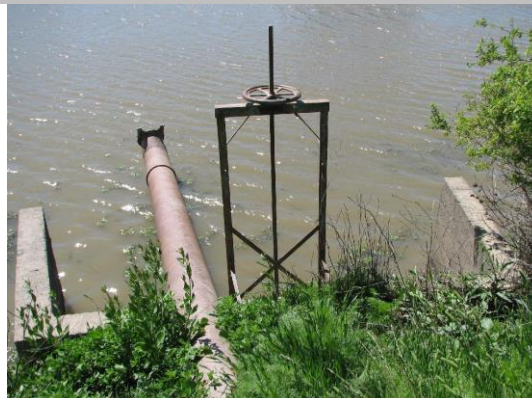
Photo 1 of 3 : UCIP_FA_2018_52538_18706.jpg

FS_ID:52538
DS_ID:19371
EP_NO: 9320
Repair Type: No Action Needed
Crossing Status: Found
UCIP Comments: 09/27/2017 see dsid 25471 for details on new pipe installed. (DWR UCIP - O. Magana)09/01/2016 Pipe has been removed and replaced during the Knights Landing 2015 Levee Repair Project. (T. Hatch/UCIP) 04/08/2013 Pipe at flap gate rusted through at WS toe. Flap gate does not function properly. (W. Wylie/UCIP) FIELD_STRUCT_DESC: *REMOVED* 1 of 2: 12-inch steel drainage pipe through the levee, 4 feet below the crown. Flap gate on the waterside (WS). Pipe is resting on a concrete headwall associated with another pipe. Siphon breaker in a 2-inch corrugated metal pipe (CMP) riser on the landside (LS) shoulder. Vertical pump unit on a concrete foundation in the irrigation ditch at the LS toe. (12-inch pipe [HLM 1.90] authorized under Automatic Board Order (ABO) issued as Permit No. 9320, 1974 - Ralph W. Pollock). [Additional Reference(s): DWR Levee Log, 1990. USACE Sacramento O&M Manual 127, June 1953, (Station 103+21.8)].

12-inch pipe at concrete headwall on WS toe.

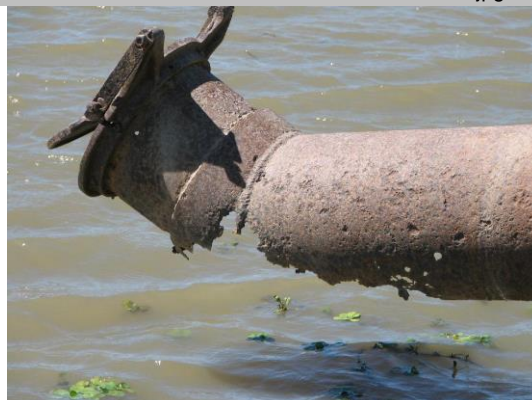
Photo 2 of 3 : UCIP_FA_2018_52538_18705.jpg

Pipe rusted through at flap gate on WS toe.

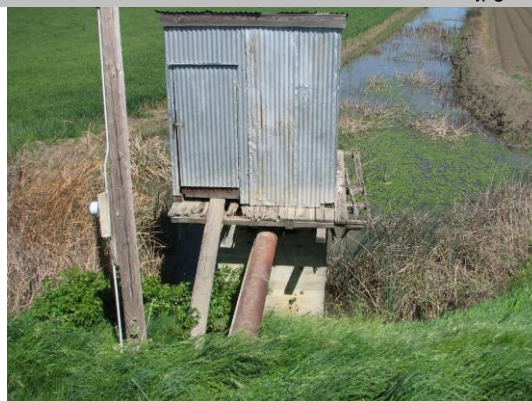
Photo 3 of 3 : UCIP_FA_2018_52538_18704.jpg

UCIP Comments: 09/27/2017 see dsid 25471 for details on new pipe installed. (DWR UCIP - O. Magana)09/01/2016 Pipe has been removed and replaced during the Knights Landing 2015 Levee Repair Project. (T. Hatch/UCIP) 04/08/2013 Pipe at flap gate rusted through at WS toe. Flap gate does not function properly. (W. Wylie/UCIP) FIELD_STRUCT_DESC: *REMOVED* 1 of 2: 12-inch steel drainage pipe through the levee, 4 feet below the crown. Flap gate on the waterside (WS). Pipe is resting on a concrete headwall associated with another pipe. Siphon breaker in a 2-inch corrugated metal pipe (CMP) riser on the landside (LS) shoulder. Vertical pump unit on a concrete foundation in the irrigation ditch at the LS toe. (12-inch pipe [HLM 1.90] authorized under Automatic Board Order (ABO) issued as Permit No. 9320, 1974 - Ralph W. Pollock). [Additional Reference(s): DWR Levee Log, 1990. USACE Sacramento O&M Manual 127, June 1953, (Station 103+21.8)].

Pumphouse on concrete platform on LS toe with JP.

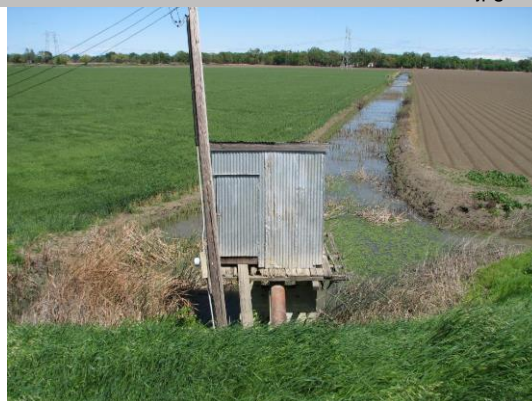
Photo 1 of 3 : UCIP_FA_2018_11305_18703.jpg

LM Start	1.90	Rating **	A/W	Issue No.	25
LM End	1.90	Issue Type +	Ma	Location *	
Category	Supplemental			GPS Latitude/Longitude	
				Start	End
Item	DWR UCIP LMA Responsibility			38.743775 °	38.743775 °
				-121.689190 °	-121.689190 °
DWR ID	19399				
Comment Code					
Inspector Comment					
FS_ID:11305 DS_ID:19399 EP_NO: 9320 Repair Type: No Action Needed Crossing Status: Found UCIP Comments: FIELD_STRUCT_DESC: 2 of 2: 24-inch steel drainage pipe through the levee, 21 feet below the crown. Slide gate on the waterside (WS) end. Open on the landside (LS) end. LS toe cobble revetted. Service pole on the LS slope. (24-inch pipe [HLM 1.9] authorized under Automatic Board Order (ABO) issued as Permit No. 9320, 1974 - Ralph W. Pollock). [Additional Reference(s): DWR Levee Log, 1990. USACE Sacramento O&M Manual 127, June 1953, (Station 103+21.8)]. FS Date: 4/9/2013

Pipe inlet located beneath pumphouse on LS toe.

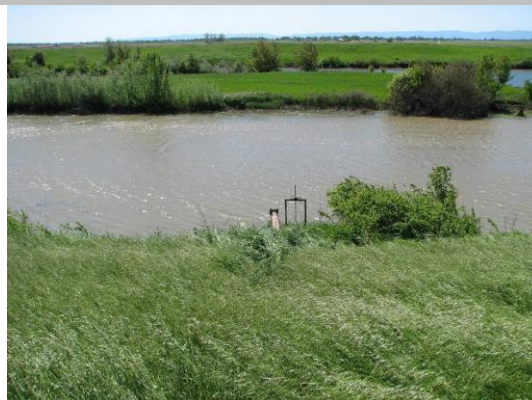
Photo 2 of 3 : UCIP_FA_2018_11305_18702.jpg

Slide gate at headwall on WS toe.

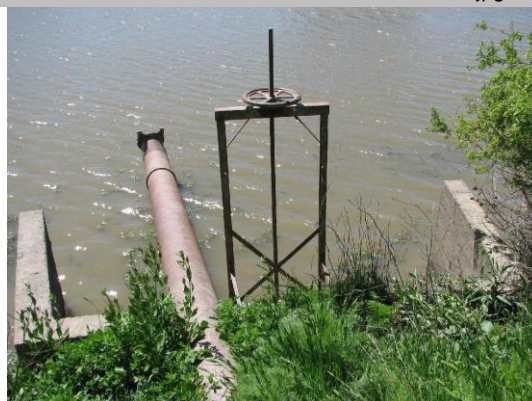
Photo 3 of 3 : UCIP_FA_2018_11305_18701.jpg

Comment Code						
Inspector Comment						
FS_ID:11305						
DS_ID:19399						
EP_NO: 9320						
Repair Type: No Action Needed						
Crossing Status: Found						
UCIP Comments:						
FIELD_STRUCT_DESC: 2 of 2: 24-inch steel drainage pipe through the levee, 21 feet below the crown. Slide gate on the waterside (WS) end. Open on the landside (LS) end. LS toe cobble revetted. Service pole on the LS slope. (24-inch pipe [HLM 1.9] authorized under Automatic Board Order (ABO) issued as Permit No. 9320, 1974 - Ralph W. Pollock). [Additional Reference(s): DWR Levee Log, 1990. USACE Sacramento O&M Manual 127, June 1953, (Station 103+21.8)].						
FS Date: 4/9/2013

Slide gate at headwall on WS toe.

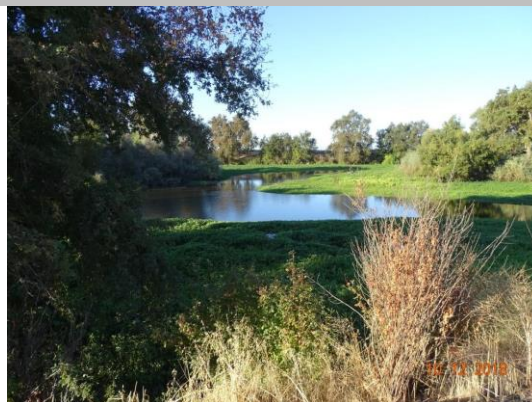
Photo 2 of 2 : FA_2018_NA0008_257_9_20181012_00024.jpg

View of the opening within the center channel. Fall 2018.

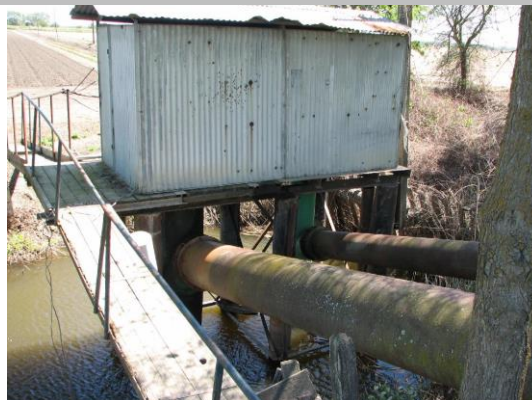
Photo 2 of 3 : UCIP_FA_2018_11293_18674.jpg

Pump and pipes on LS toe.

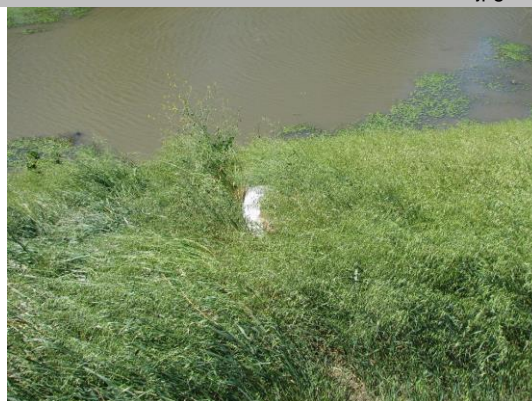
Photo 2 of 3 : UCIP_FA_2018_11291_18668.jpg

Comment Code						
Inspector Comment						
FS_ID:11291						
DS_ID:19401						
EP_NO: 9317						
Repair Type: No Action Needed						
Crossing Status: Found						
UCIP Comments:						
FIELD_STRUCT_DESC: 2 of 2: 24-inch steel discharge pipe through the levee, 9 feet below the crown. Pump house on pile structure in drainage ditch on the landside (LS). Siphon breaker on the pipe on the waterside (WS) with a butterfly shutoff valve. Service pole at the pump house. (Permit No. 9317, 1974 - Reclamation District No. 819). Pipe replaced in 2012. [Additional Reference(s): DWR Levee Log, 1990. USACE Sacramento O&M Manual 127, June 1953, (Station 210+99)].						
FS Date: 4/9/2013

Pipe in grass on WS shoulder.

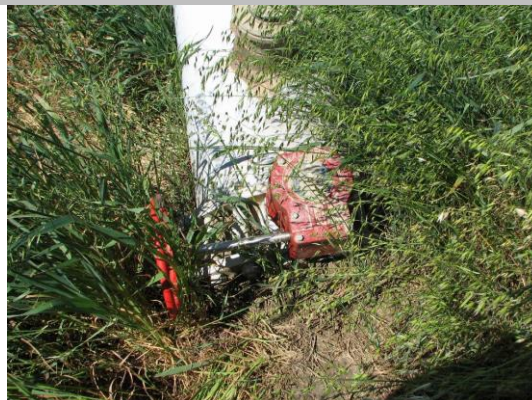
Photo 3 of 3 : UCIP_FA_2018_11291_18667.jpg

Siphon breaker and butterfly valve on WS shoulder.
